## Discussion

Lateral heterogeneity of strain in strained Si/SiGe materials can be a serious problem for the manufacturability of high mobility ICs that use these materials.

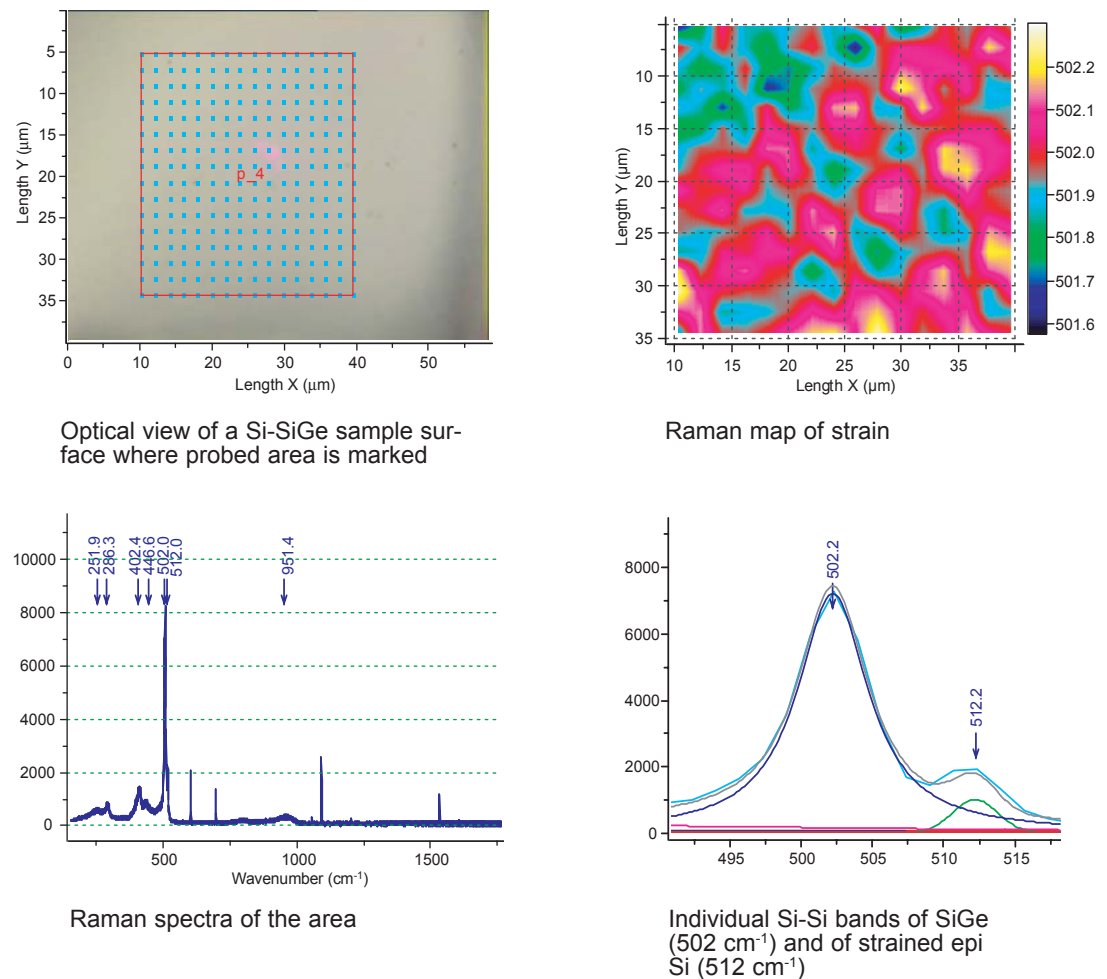
Figure 1. Mapping of Si-Si Mode of SiGe

Visible Raman spectroscopy is used to probe the lateral strain in the underlayer SiGe of strained Si on Si<sub>(1-x)</sub>Ge<sub>x</sub> substrate structures (cf. "In-plane strain fluctuation in strained-Si/SiGe heterostructures," Sawano et al, Appl Phys. Lett. V83, p. 4339, 2003). These structures typically have a thin (~10 nm) strained Si layer on top of a thicker (~ microns) SiGe layer on a Si substrate. A square area (~30X30 micron) was mapped using a visible Raman spectrometer excited with an Ar<sup>+</sup> ion laser (514.5 nm wavelength, 1 mw in the sample, 1 micron spatial resolution) (Figure 1). The map represents the strained Si-Si spectral band in the SiGe underlayer. Unlike the UV Raman, the visible source results in a much deeper penetration, i. e. , analysis of the stress in the underlying SiGe layer.

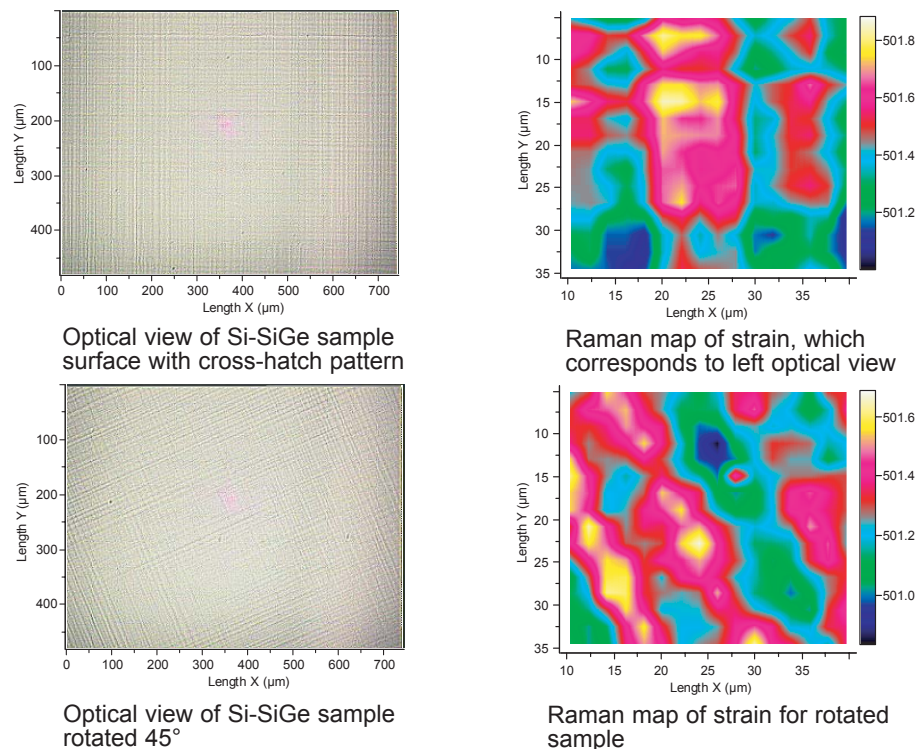
Figure 2. Cross Hatch Pattern

A clear pattern of wavenumber emerges along the  $\langle 110 \rangle$  directions and is conserved when the physical sample was rotated with  $\sim 45^\circ$  around the Z-axis (Figure 2). The Si-Si wavenumbers (in the SiGe) depend both on the Ge concentration and on the residual, unrelaxed strain developed in the SiGe due to lattice mismatched systems heteroepitaxial grown of SiGe beyond its critical thickness. The lattice mismatch results in the formation of misfit and associated threading dislocations which lead to the characteristic cross-hatch pattern typically seen on the Si strained epilayer surface. The Si-Si wavenumber pattern in the SiGe layer should be a stress related pattern caused by the strain developed in the SiGe layer and not to any lateral Ge distribution on the micron scale, as the Raman mapping (imaging) mimics the cross-hatch usually observed optically (Figure 2) or through AFM. The lateral scale of stress variations depends on the individual samples and is found to be from 4 to 12 micron (ridge to ridge) with a stress range up to 0.2 GPa. The lateral scale of 12 microns is close to the cross-hatch pattern of the optical image of the sample (Figure 2) and is comparable to the threading dislocation densities of  $10^6/\text{cm}^2$ .

As the penetration depth of 514.5 nm light is  $\sim 0.5$  micron in SiGe samples with  $\sim 30\%$  Ge, the strain cross-hatch pattern is related to the same stress distribution developed through the entire layers of Si-SiGe, which are  $\sim$  few microns thick.
