## AN 401

# Proper SIMS Quantification of Boron in SiGe structures: Comparison of Cs and O Ion Beam Bombardment

May 7, 2007 (Version 3.0)

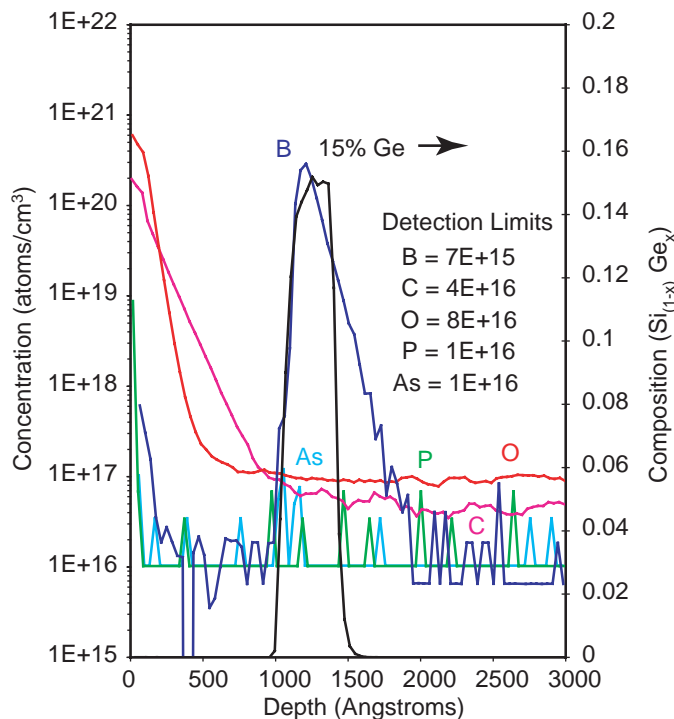
Figure 1. SiGe Analysis Using 2keV Cs

The analysis of SiGe structures by SIMS using Cs ion bombardment does not provide an accurate profile shape for Boron. Known limitations of this analysis include significant tailing of the boron profile from Cs knock-on and chemical segregation effects. In order to obtain the most accurate data for these SiGe structures, EAG recommends that two separate SIMS analyses be performed.

SiGe structures are analyzed using Cs ion bombardment to obtain accurate compositional information and low background levels of atmospheric contaminants. Figure 1 shows the typical negative ion profile acquired using Cs ion bombardment. B, C, O, P, As and Ge were acquired simultaneously and quantified in one analysis at minimal cost. The Ge composition is obtained with  $\pm 3\text{-}5\%$  accuracy up to 80% Ge, together with very low detection limits for C and O. However, the known limitations of analyzing boron with Cs ion bombardment results in a distorted tail shape. Figure 2 shows a typical positive ion profile acquired using O ion bombardment. This analysis accurately shows the true boron concentration profile shape. Using this analysis, it is easily observed that the boron dopant is entirely contained within the SiGe layer and that two spikes are observed at the Si/SiGe and SiGe/Si interfaces. Based on these data, EAG strongly recommends that two analyses be performed for the proper quantification of B, C, O, P, As and Ge in SiGe structures.

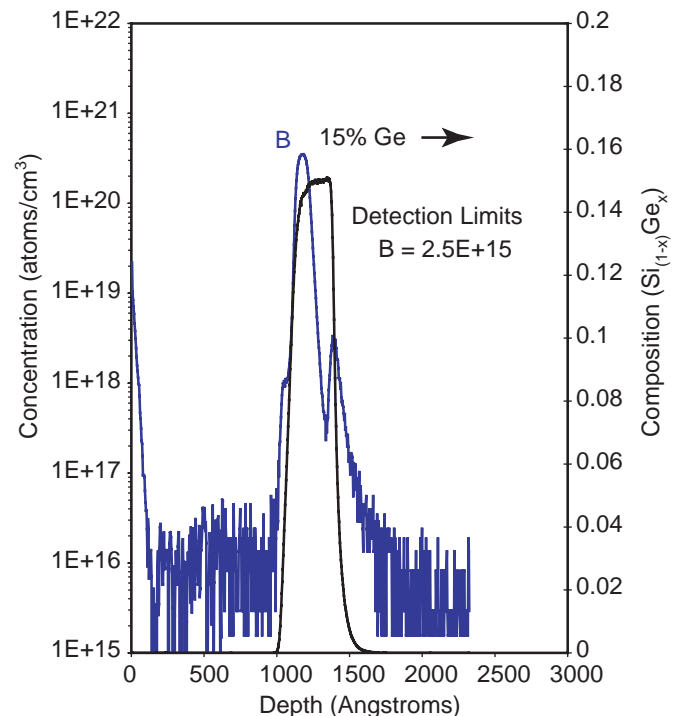
Figure 2. SiGe Analysis Using 1keV O<sub>2</sub> w/O-leak

To meet current market financial needs, and when the most accurate B profile shape is not needed, EAG offers the analysis of SiGe structures using Cs bombardment at a basic cost of one unit per sample. For this unit charge Ge composition, dopant concentrations and low background levels of atmospheric contaminants are provided using a quadrupole based SIMS instrument. As illustrated below, if the shape of the boron profile is critical to the analysis, a second profile using O ion bombardment is necessary.
